# INFLUENCE OF GEOTECHNICAL CHARACTERISTICS ON CRACKS IN BUILDINGS: A CASE STUDY

Selvamsagayaradja.M<sup>1</sup> , V. Murugaiyan<sup>2</sup> , T. Sundarajan<sup>3</sup>.

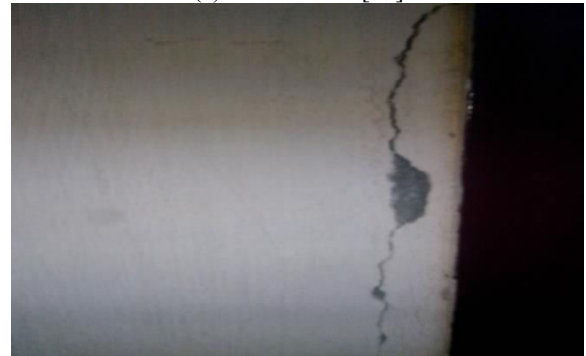
(a) Location 1-[L1]

At the beginning of the study, the length and width of the cracks were marked and were monitored from time to time find out whether there is any change in the above over a period of time. In L1, cracks were observed near the corner of the wall along the vertical direction and the cracks are seen to have been initially developed from the floor towards the height of the wall. In L2, cracks have developed near the junction of columns and beams. Diagonal cracks have developed from the corner of window sill towards the wall end and vertical cracks have developed from the lintel towards the floor making the wooden frame distorted, in L3 and L4. Multiple hair line cracks have developed along the external wall of the buildings in L5 and L6. Fig. 1(a) to 1(f) shows the crack sizes and orientation in the buildings in locations 1 to 6. Details of cracks like length, width and orientations in all the buildings are given in table 2.

Results of the tests conducted on the disturbed and undisturbed soil samples collected from locations L1 to L6 are summarized and given in table 3. It is seen that the liquid limit (LL) of soil samples in L1 to L4 are greater than 50 and hence they are classified as 'silt and clays of high compressibility' i.e. 'CH' soil as per IS code. As the LL of soil samples in L5 and L6 are in the range of 35-50, they are classified as silt and clays of medium/intermediate compressibility i.e. 'CI' soil. The shrinkage limit (SL) value of L1 to L4 indicate 'high shrinkage', whereas L5 and L6 are found to be low shrinkage. Further, it is seen that the natural moisture content in locations 2 to 6 is less than half the liquid limit of the soil specimens in the locations. This shows that the clay layer has undergone significant desiccation, this responsible for causing distress in buildings in locations 2 to 6. On the other hand, due to constant water logging the natural moisture content is on the higher side and that is reasonable for causing distress in the building in location 1.

Based on field data collected, and laboratory test results and visual observations of cracks in buildings in location 1 to 6, it can be concluded that (i) The distress in buildings at locations 2 to 6 is attributed to the presence of CH/CI type of soil and their significant desiccation; (ii) the distress in building at locations 1 is attributed to constant water logging over CH type of soil.
