Investigation on the progressive damaging failure of Kevlar hybrid composite pipe

Abstract — Composite materials are continuously gaining more importance in the field of engineering. In this paper we have focused mainly on hybrid fiber reinforced polymer composite materials as pipe. This work concentrates on the hybrid (Aramid and Glass) fiber as a reinforcement of the epoxy matrix. The advantage of hybridization is to increase the strength of hoop tensile strength and stiffness of pipe used in industry application. The aim of paper is to study the progressive damage failure analysis of hybrid fibre pipe. We had produced specimen for making a lightweight, energy absorbing, glass fiber reinforced aramid fiber, Aramid fiber reinforced glass fiber composite pipe and explore through the effect of lateral compressive response was analysed. A very good agreement was observed between experimentally measured apparent hoop tensile strength of hybrid fibre reinforced epoxy pipes and predicted values employing progressive damage modelling.

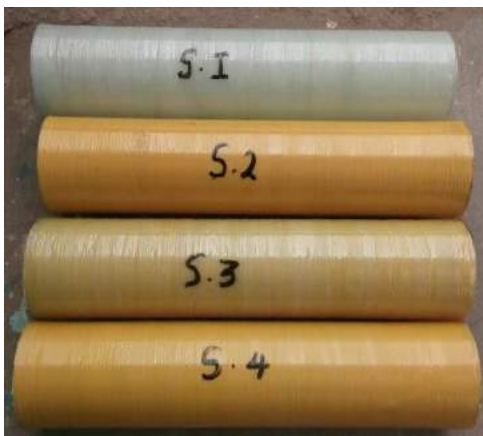
Fig. 2.Specimens for lateral crushing.

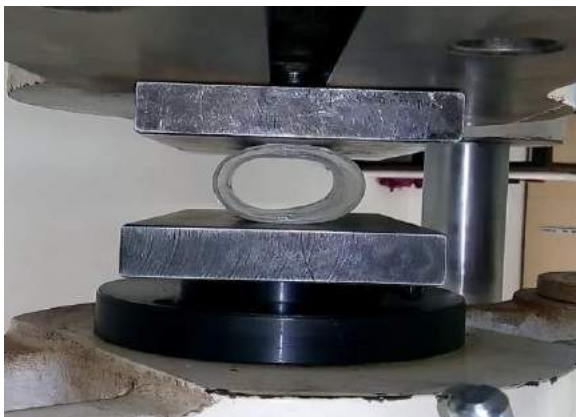
Fig. 6. Failure of specimens under lateral crushing loading at a rate of 1 mm/min

In this research, lateral crushing strength was tested in UTM machine (Fig.6). Four different specimen was tested for observing the stiffness factor and stiffness strength. According to ASTM D2412 the specimen was cut and placed in between the parallel plate's in UTM machine. Crushing Load with respect to deflection was observed from experiments.

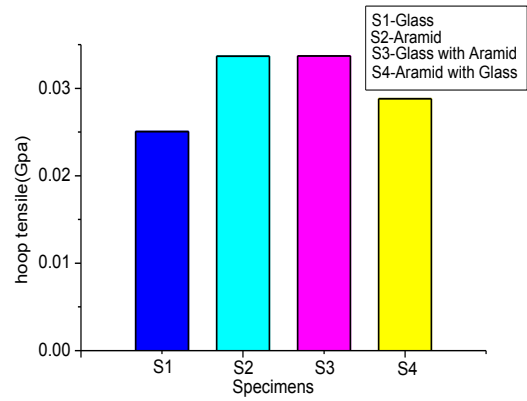
Fig .11. Graphs showing Apparent hoop tensile strength with different pipe specimen

which is indicative of hoop tensile strength of Kevlar fiber with glass. Fig.11 shows apparent hoop tensile strength has raised for glass reinforced aramid pipe. This indicates that energy dissipated for plastic deformation at the outer layer and elastic deformation at inner layer of aramid pipe. The damage is not significantly changed due to hybridization of pipe. It was observed that the glass hybrid pipe with stand the high load when compared to other composite pipes. Thus it possesses good hoop tensile strength. The average experimental value was arrived to draw the graphs from the value of three samples for each composite pipe.

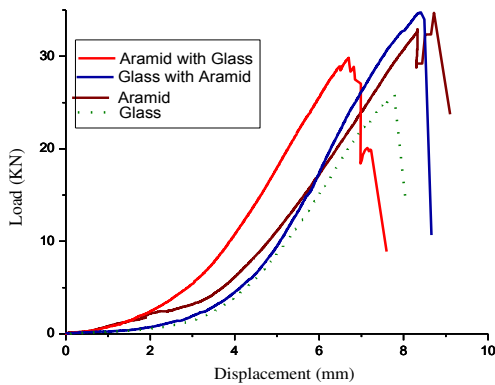
Fig .9. Graphs showing tensile load with deflection

Load–displacement plots illustrating that energy absorption potential of the samples showed that in homogeneous and hybrid condition (Fig. 9). The elastic energy has absorbed in the surface area of outer layer and the fracture was initiated at the curve surface of composite pipe under axial tensile load. Glass reinforced Kevlar pipe has increased hoop tensile strength compared to others samples due to delay in debonding at outer layer of composite pipe. Fig.10 shows for increasing strain with increased stress in glass reinforced Kevlar composite,

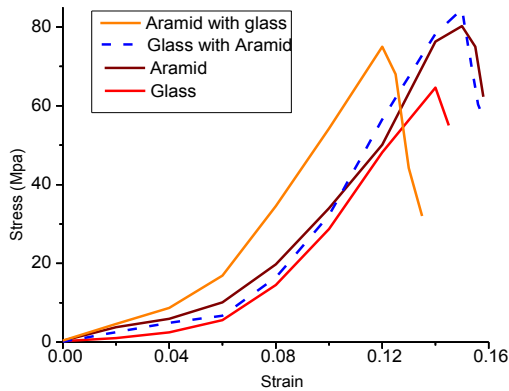
Fig .10. Graphs showing stress with strain

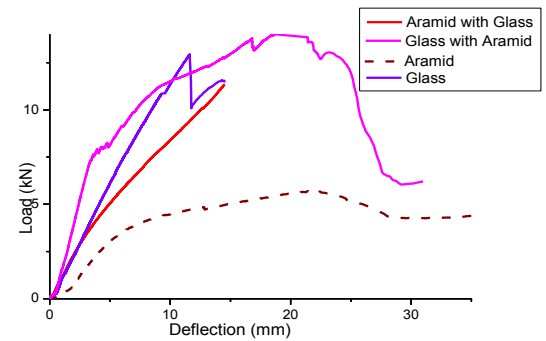
Fig .12. Graphs showing crushing load with deflection

From the Fig.12, the deflection was increased with increasing of crushing load applied. The glass reinforced aramid pipe has maximum load absorbing capacity. The elastic region is reached at the displacement of 20mm and initiated to get fracture after the peak load 14.56 kN. The outer layer has more load carrying capacity compared to inner layer. The interaction effects between the layers are delay in debonding with epoxy matrix. Fig 13-14 shows evaluate the effect of stiffness parameter in glass hybrid pipe which has more stiffness strength with change of displacement.

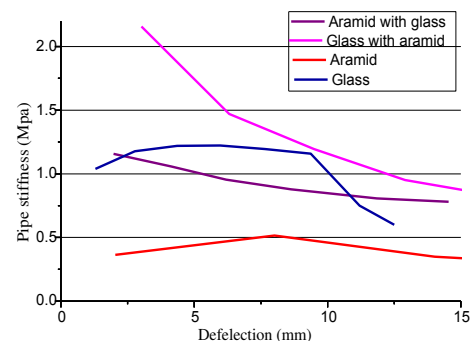
Fig .13. Graphs showing pipe stiffness with deflection

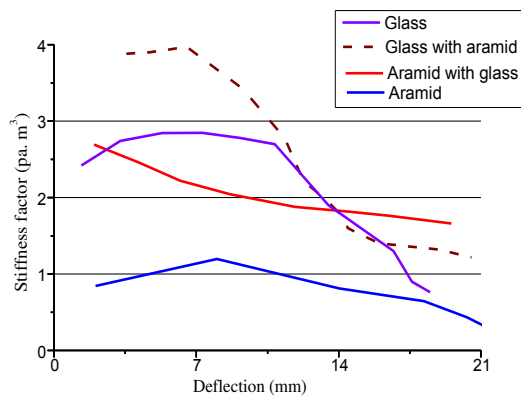
Fig .14. Graphs showing stiffness factor with deflection
