Protective Coatings on Concrete Surface for Corrosion Prevention of Steel

Abstract. The presence of micro cracks, pores, voids, fissures and capillaries on the concrete surface permits the ingress of water and other aggressive species from the environment into the concrete which leads to deterioration of concrete and corrosion of embedded steel in concrete. One of the best ways to manage this durability issue is surface coatings to concrete. Coating usually covers all such defects and furnishes uniform durable surface finish. In this study, several coatings were developed by using polyvinyl acetate (PVA) as binder with some functional pigments such as Silica fume, Nano silica, Micro silica, Alumina clay, TiO₂, etc., These coatings were subjected to various durability tests such as Field exposure, Chemical exposure, Flame exposure, Chloride ion diffusion, Impressed voltage test and TAFEL extrapolation techniques and the best coatings are selected based on regress tests and analysis.

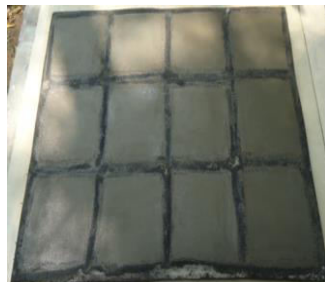
Fig. 1 Rubber mould with cast Mortar tiles

Mortar square tile specimens of 100 mm x 100 mm x 10 mm, as shown in Fig. 1, were cast to evaluate water absorption, chemical resistance and field exposure of all the coatings.

Square tile specimens (100 mm x 100 mm x 10 mm) were cast by using rubber moulds. Hollow core specimens (outer – 83 mm x 50 mm and inner – 40 mm x 25 mm) were cast by using PVC pipes being inserted at the centre when the cylindrical moulds were partially filled with mortar and finally lifted after finishing.

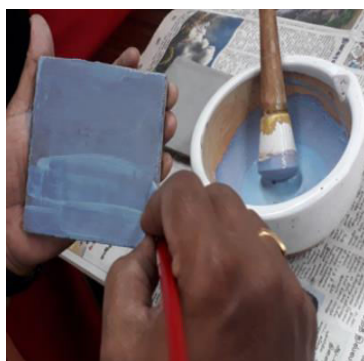
Fig. 3 Coating by Brush

The surface of the mortar specimens were dripped with water just before applying the coatings [5]. After preparation of the surface, the coatings were applied with a brush as shown in Fig. 3 and dried for 24 hours at room temperature.

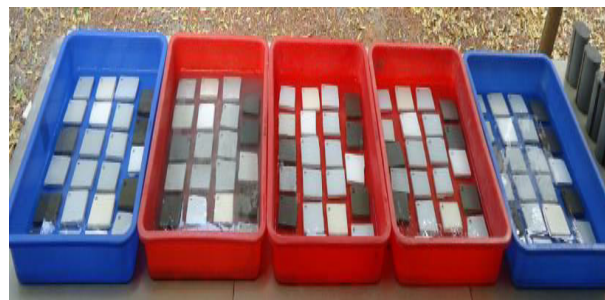
Fig. 5 Specimens immersed in different Chemical solutions

Square tile specimens of 50 mm x 50 mm x 10 mm were coated on five faces (except bottom surface) with the surface coatings. The coated specimens were immersed in the following chemical solutions as shown in Fig. 5:

- 1% Hydrochloric acid solution,
- 1% Sulphuric acid solution,
- 1% Magnesium sulphate solution,
- 1% Urea solution,
- Distilled water.

The immersed specimens were visually studied periodically for signs of coating deterioration such as swelling, cracking, scaling, discoloration and crumbling of edges.

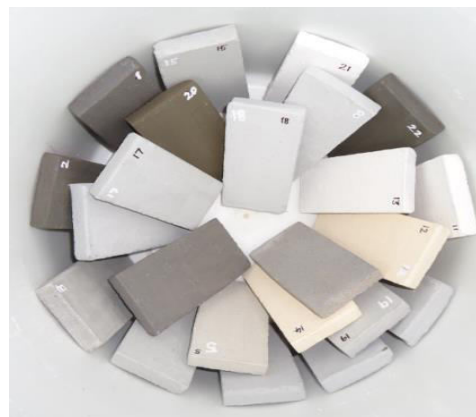
Fig. 6 Specimens immersed in Water

1) *Tiles*: Half tile specimens of 100 mm x 50 mm x 10 mm were coated on all the faces and dried for 24 hours. The coated specimens were initially weighed and then immersed in a water tank as shown in Fig. 6. The increase in weight of the immersed specimens was recorded at regular intervals up to 48 hours and plotted against time. This weight increase indicates water absorption of the coated and uncoated specimens.

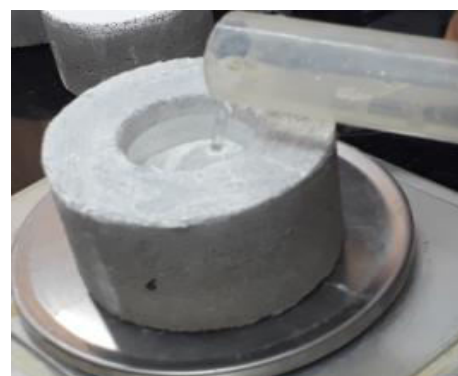
Fig. 7 Refilling the core

2) *Hollow Core*: The coatings were applied on the hollow core (40 mm ϕ x 25 mm) of cylindrical specimens (83 mm ϕ x 50 mm). The coated specimens were weighed initially and then the hollow core was poured with water as shown in

Fig. 7. The reduction in water level in the hollow core due to water absorption was noticed at regular intervals by refilling the hollow core (for every 1 hour) up to 24 hours. The water absorption percentages were obtained by correlating the recorded values and plotted against time.
