Study of crack width assessment and propagation in RCC & masonry structures

Abstract—The structures that are exhibiting rapid sign of distress requires immediate assistance in order to identify the underlying causes of their distress, constitute an accurate diagnosis, and determine the most appropriate approach for proper treatment and the rehabilitation of the structures. If not addressed properly these changes could cause distress. Both RCC and masonry construction will undoubtedly develop cracks over time. One of the specifications for structural concrete elements serviceability is the crack width calculation which results due to low tensile strength of concrete. When subjected to service loads. For concrete structure to resemble appealing and to last for a long time, controlling cracking is crucial. In this paper, the degradation of RCC and masonry structures is investigated experimentally. The crack measurement gauge is utilized in this empirical investigation to monitor the cracking in the structures. The degree of structural threat associated with a building can be established through the identification of such cracks. The cracks characteristics obtained from the experiment

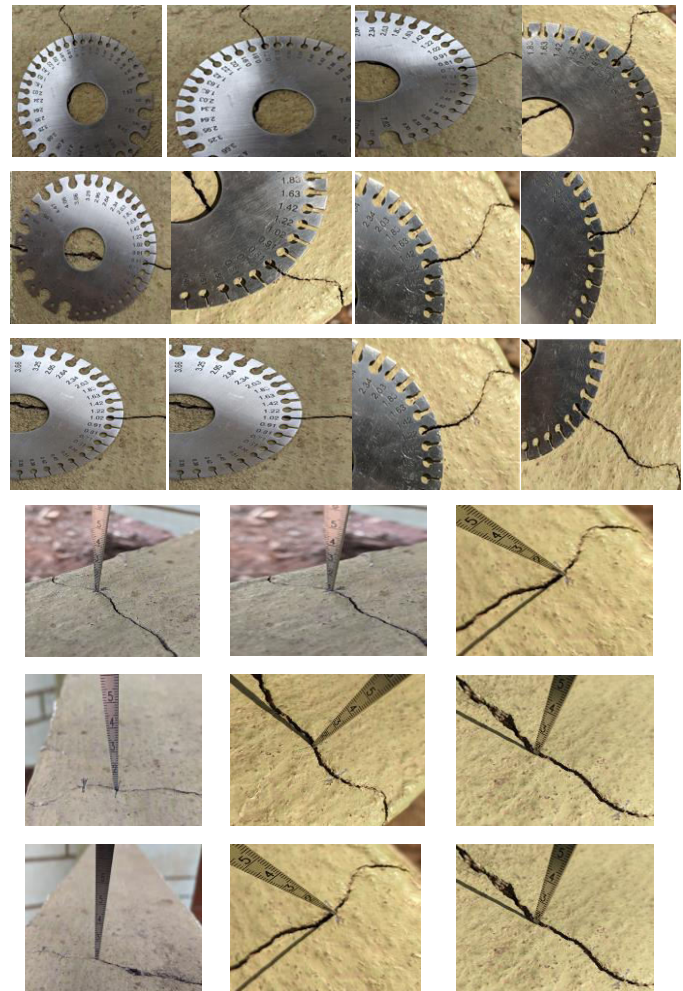
The RCC structure monitored for crack width is located in Farmagudi Goa (G+1) structure and is about 54 years old. Figure 1 shows the site measurements of crack width and depth taken at the Farmagudi site for a masonry building in the campus, each photograph shows crack width and depth measurement in every week. Table 1 shows the crack width and depth measured in each week at this site.

Fig. 1. Case study 1 displaying the measurement of the cracks in a structural component.

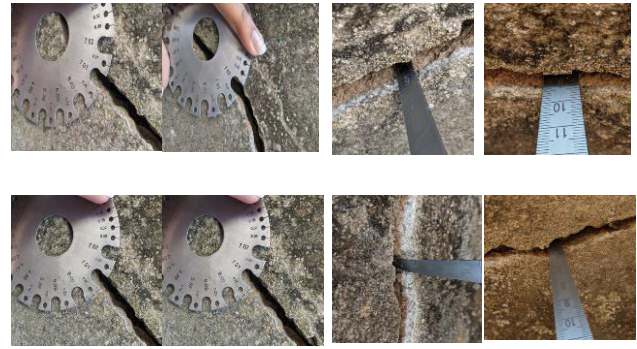
The building under consideration for this case study is located in Old Goa and is about 25 years old RCC G+5 building. Figure 3 shows the site measurements of crack width and depth taken at the Old Goa site for the G+5 building. Table 2 shows the crack width and depth measured in each week at this site.

Fig. 3. Case study 2 displaying the measurement of the cracks in a structural component.

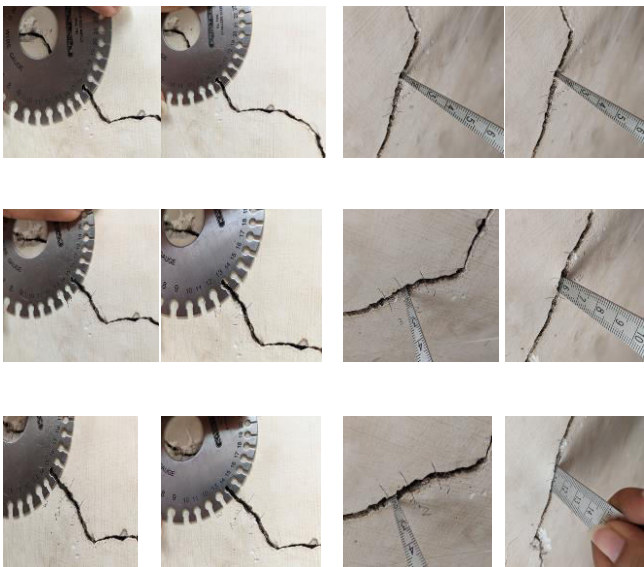
The building under consideration for this case study is located in Khorlim Goa and is about 25 years old RCC G+5 building. Figure 5 shows the site measurements of crack width and depth taken at the Khorlim Goa site for this building. Table 3 shows the crack width and depth measured in each week at this site.

Fig. 5. Case study 3 displaying the measurement of the cracks in a structural component.
